MACHINE SERVICE BULLETIN #32

SUBJECT: Interference between
Lug in Carriage & K843D in
"2" Series Machines

DATE: March 1, 1926

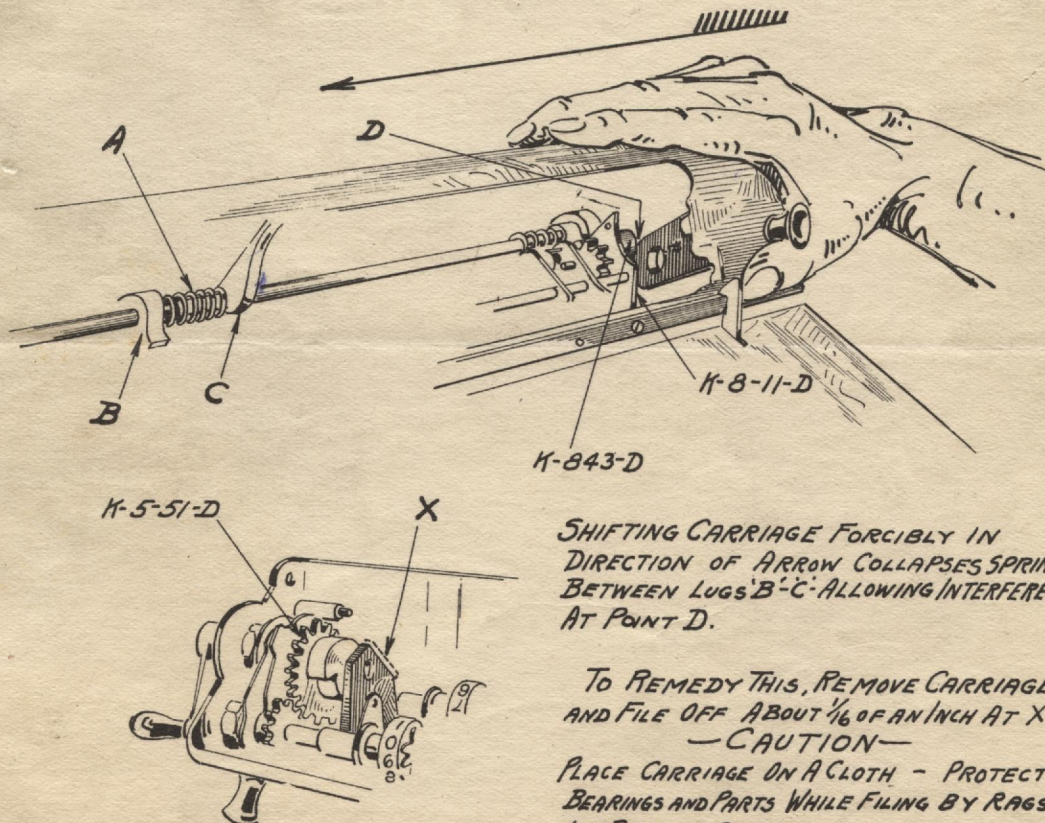
We have recently discovered that when shifting the carriage from the extreme right hand position to the extreme left hand position forcibly, by the use of the carriage lift handle, K5-85D (in this manner only) that it is possible for an interference to occur between the lug on the right of the carriage case which serves as a bearing for the K5-51D, registering dial clearing gear, and the bushing K843D for the eccentric gear, in K8-11D, bracket for right hand eccentric gear.

It is noted that when shifting a carriage in this manner, the left bumper spring collapses enough to cause the lug in the carriage to strike K843D as described above, with the result that as K8-11D supports the carry counting mechanism on the right of the machine, this mechanism may become distorted and thereby cause it to be out of adjustment, through this repeated interference.

SHIFTING CARRIAGE FORCIBLY IN
DIRECTION OF ARROW COLLAPSES SPRING A
BETWEEN LUGS B-C-ALLOWING INTERFERENCE
AT POINT D.

TO REMEDY THIS, REMOVE CARRIAGE -
AND FILE OFF ABOUT $\frac{1}{16}$ OF AN INCH AT X
— CAUTION —

PLACE CARRIAGE ON A CLOTH - PROTECT
BEARINGS AND PARTS WHILE FILING BY RAGS
IN PROPER PLACES.
